WATER QUALITY M E M O R A N D U M

Utah Coal Regulatory Program

RE: 2008 Fourth Quarter Water Monitoring, Genwal Resources, Inc., Crandall Canyon Mine, WQ08-4, Task ID #3141

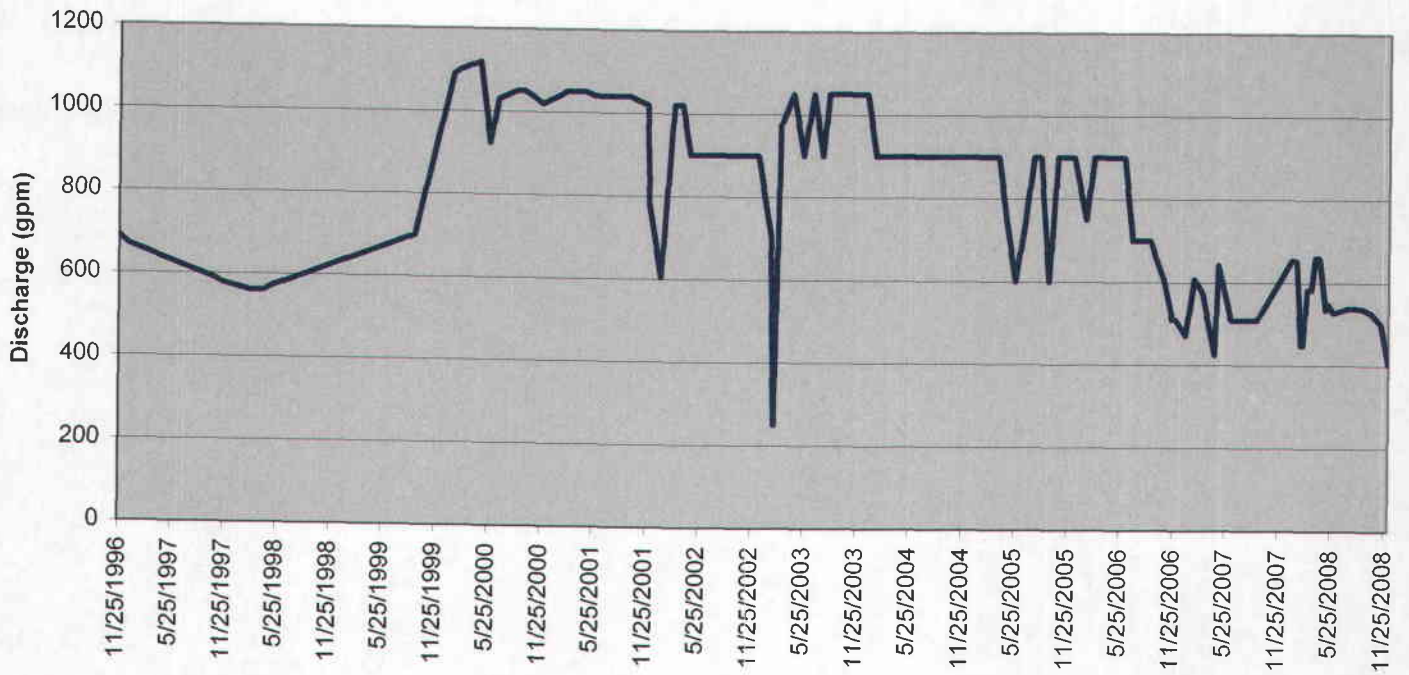
Mine Water Discharge (Outfall 002)

The 4th quarter analytical results of the mine-water discharge produced elevated levels of T-Fe, while TDS levels remained within compliance levels. Two of three sampling events produced T-Fe values higher than the 1.0 ppm range established in the UPDES permit (1.59 ppm and 1.335 ppm). All three sampling events produced TDS levels well below the 1,200 ppm compliance level (772 ppm, 786 ppm and 819 ppm).

Continued data collection and monitoring of the mine-water discharge will be necessary to determine if a trend is emerging relative to TDS and T-Fe. The data will be essential in determining whether the mine-water discharge remains in compliance with the UPDES permit.

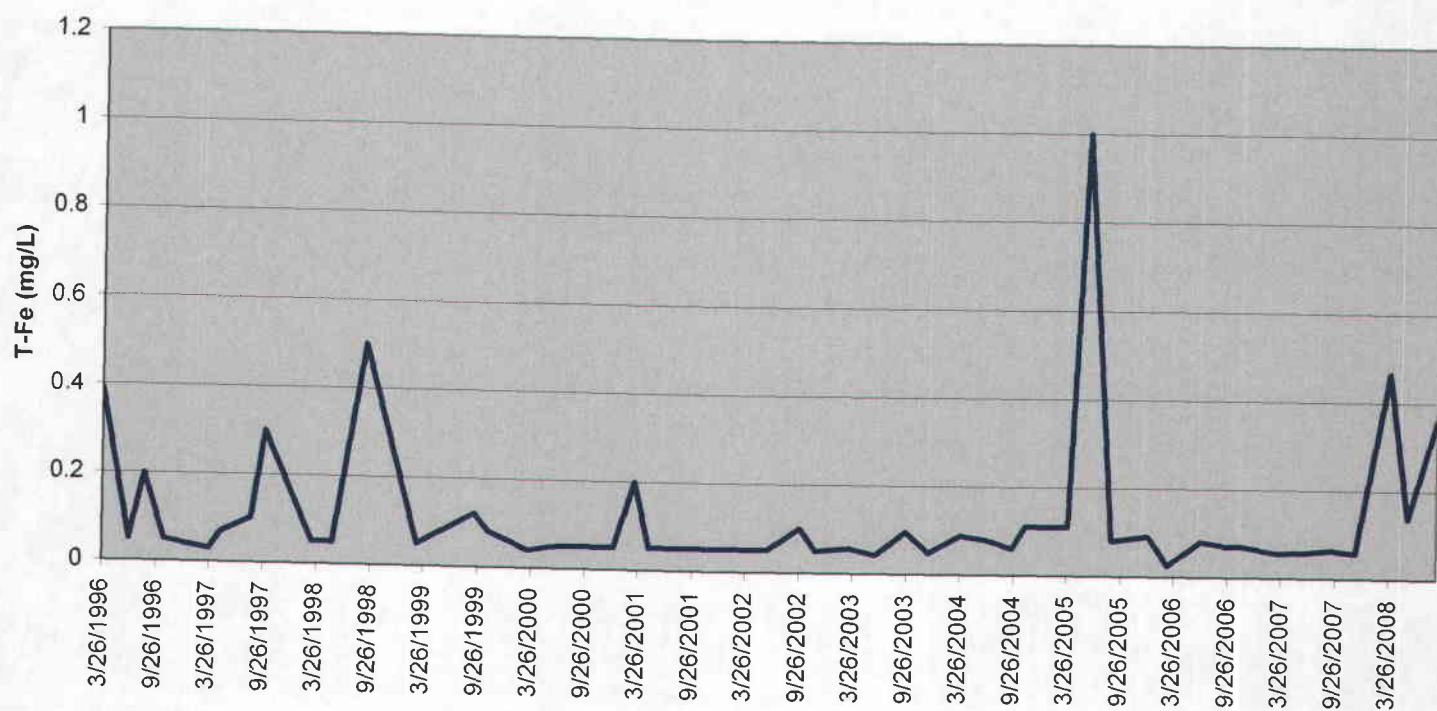
Crandall Creek Lower Flume (LOF-1): Total Iron Levels

However, the T-Fe level obtained at Site LOF-1 (1.438 ppm) was well above the 1 ppm standard established in the UPDES permit. It's clear that the T-Fe contained within the mine-water discharge is producing a detectable increase further downstream from the outlet of Outfall 002.

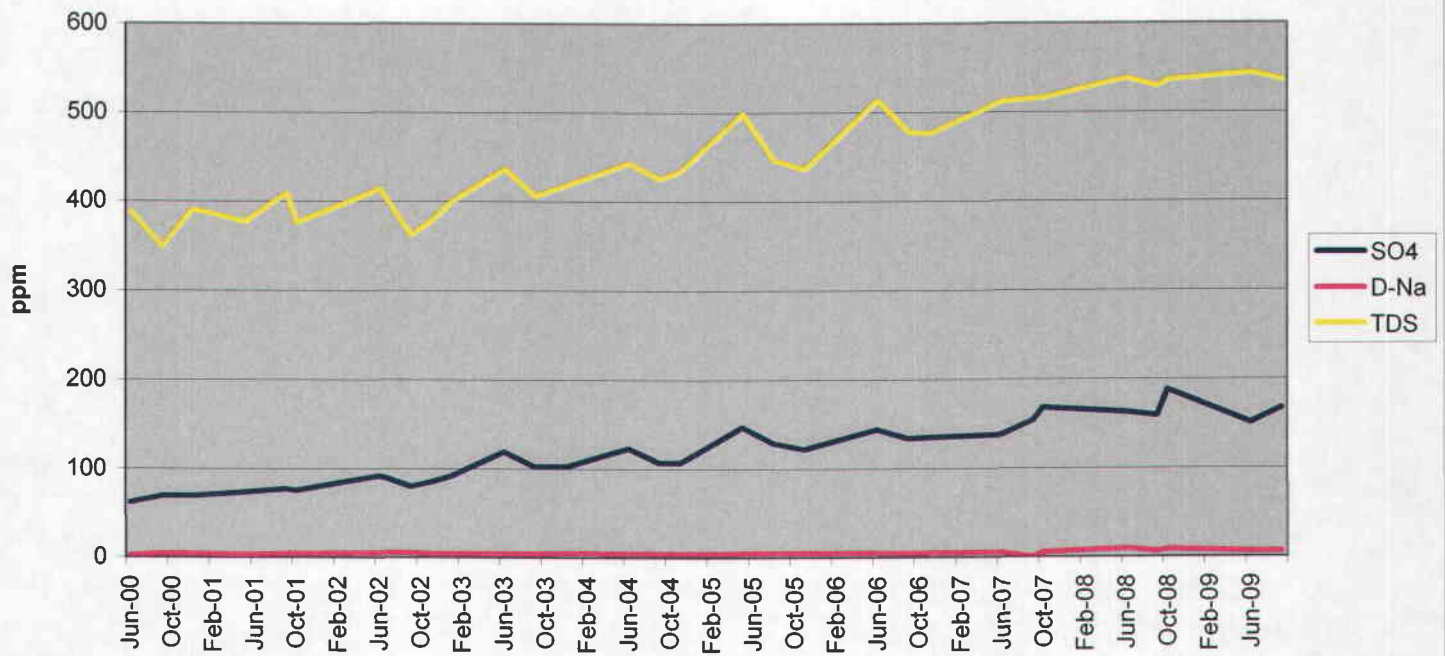
Spring SP-58 Water Quality

Spring SP-58 produced several analytical results that were outside 2 standard deviations: D-Na (2.72 standard deviations), SO4 (2.41 standard deviations) and TDS (2.01 standard deviations). (See Attached Chart)

SP-58 will be examined thoroughly going forward. Dissolved sodium (D-Na) is trending significantly upward.
